MNM Fatal 2007-25

- Powered Haulage Accident
- September 20, 2007 (Alaska)
- Sand & Gravel Operation
- Plant Laborer
- 49 years old
- 32 years experience

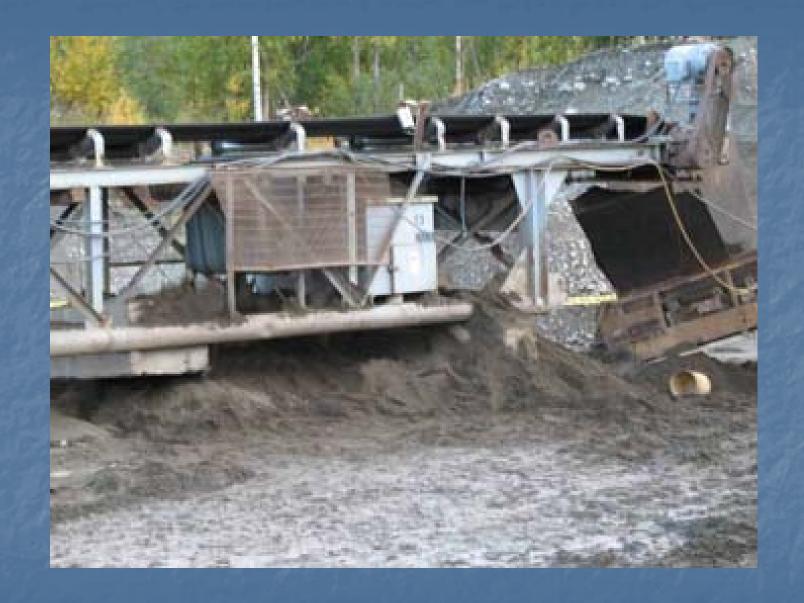
The victim was fatally injured when he became entangled in a belt conveyor take-up pulley at the wash plant. He entered the area to shovel spillage. He gained access to the take up pulley through the conveyor frame work.

The procedures and controls to remove spillage around belt conveyors were not followed. The belt conveyor was not deenergized and blocked against hazardous motion before persons removed spillage.

- Establish policies to ensure employees are trained to safely remove spillage near moving conveyor belts.
- Before assigning miners to clean up spillage, have them identify hazards and demonstrate how they would safely complete the tasks. Stop, Look, Analyze, Manage (SLAM)
- Deenergize and block conveyor belts against motion before working near the drive, head, tail, and take-up pulleys.
